**Flood Control Project Maintenance
Levee Inspections****LMA District Cover Sheet****Spring 2014 Levee Inspection Results****Reclamation District No. 0544 Upper Roberts Island**

Spring 2014 Levee Inspection Results

Reclamation District No. 0544 Upper Roberts Island

Waterway			Bank	Unit Miles
Unit No. 01 San Joaquin River			Left	6.11
	Spring (March - May)	Summer (June - August)	(September - November) Fall	Winter (December - February)
Unit Maintenance Rating (Fall Only)				
Date of Inspection	04/10/2014 - 04/10/2014			
DWR Inspector	Richard Willoughby			
Accompanied By

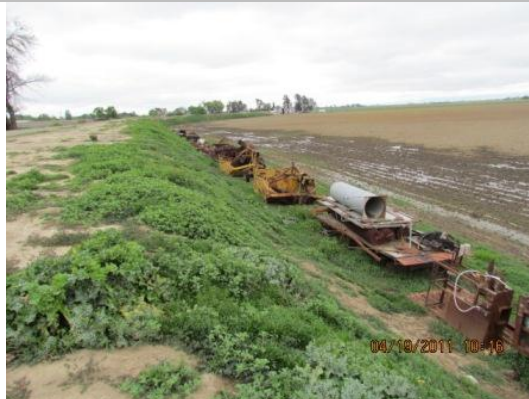
Photo 1 of 2 : richard_s_20140320_285.jpg

LM Start	0.23	Rating **	M	Issue No.	4
LM End	0.23	Issue Type +	Ma	Location *	LS
Category	Earthen Levee			GPS Latitude/Longitude	
				Start	End
Item	Encroachments			37.867590 °	37.867590 °
				-121.327813 °	-121.327813 °
DWR ID	DWR_RD0544_01_s _ 2012_4				
Action/Comments					
Equipment Inspector Comments: Farm equipment and supplies stored at landside toe.

Looking south at equipment along landside toe.

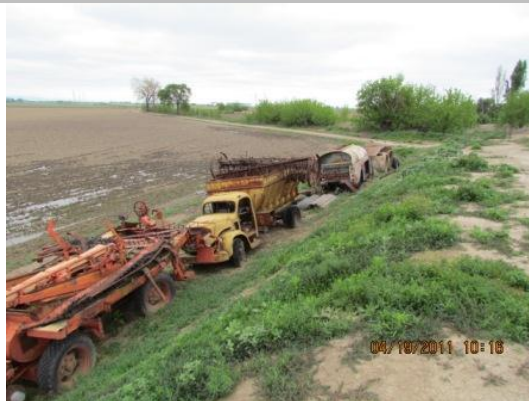
Photo 2 of 2 : richard_s_20140320_286.jpg

LM Start	0.23	Rating **	M	Issue No.	4 (cont)
LM End	0.23	Issue Type +	Ma	Location *	LS

Looking north at equipment along landside toe.

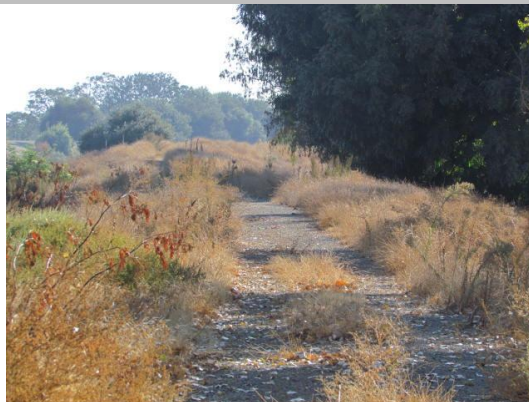
Photo 1 of 2 : richard_s_20140320_284.jpg

Looking south at overgrown on landward and waterward slopes.

LM Start	0.48	Rating **	M	Issue No.	3
LM End	0.68	Issue Type +	Ma	Location *	WS
Category	Earthen Levee			GPS Latitude/Longitude	
				Start	End
Item	Vegetation			37.864578 °	37.863753 °
				-121.326210 °	-121.322835 °
DWR ID	DWR_RD0544_01_s_2012_3				
Action/Comments					
Remove the wild growth other than native grasses from the levee slopes.

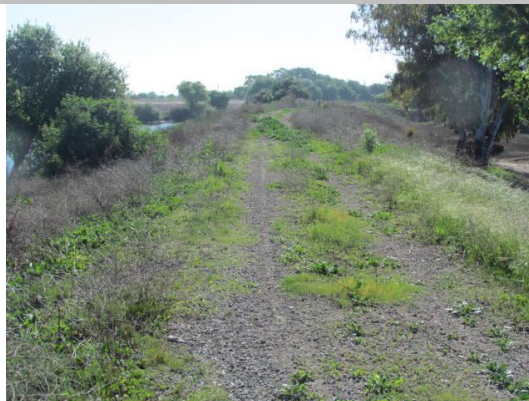
Photo 2 of 2 : richard_s_20140411_530.jpg

Looking south at typical view of levee. (Spring 2014)

LM Start	0.48	Rating **	M	Issue No.	3 (cont)	
LM End	0.68	Issue Type +	Ma	Location *	WS	
Category	Earthen Levee			GPS Latitude/Longitude		
				Start		End
Item	Vegetation			37.864578 °	37.863753 °	
				-121.326210 °	-121.322835 °	
DWR ID	DWR_RD0544_01_s _ 2012_3					
Action/Comments						
Remove the wild growth other than native grasses from the levee slopes.

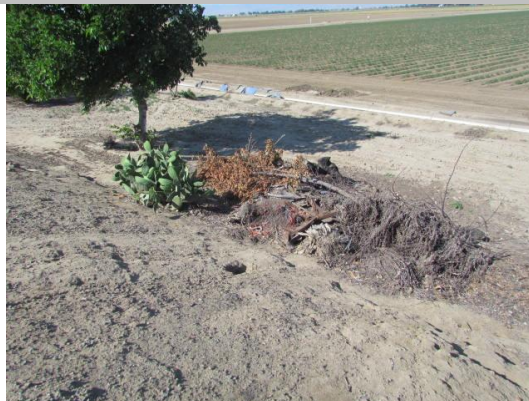
Photo 1 of 1 : richard_s_20140320_288.jpg

LM Start	2.34	Rating **	M	Issue No.	7
LM End	2.34	Issue Type +	En	Location *	LS
Category	Earthen Levee			GPS Latitude/Longitude	
				Start	End
Item	Encroachments			37.847108 °	37.847108 °
				-121.324585 °	-121.324585 °
DWR ID	DWR_RD0544_01_s _ 2012_7				
Action/Comments					
Garbage					
Inspector Comments: Garbage and prunings at landside toe.

Looking southwest at garbage at landside toe.

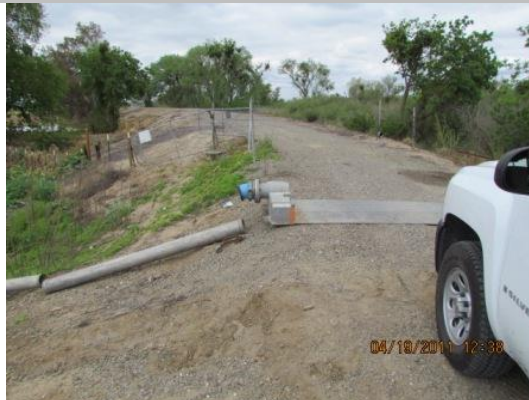
Photo 4 of 8 : richard_s_20140320_293.jpg

Looking north at pipe and pipe ramp on landside and crown of levee.

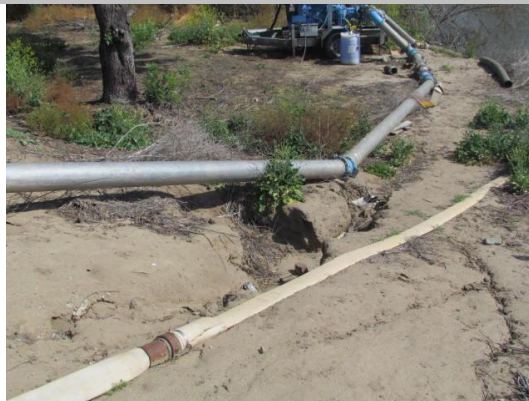
Photo 6 of 8 : richard_s_20140320_295.jpg

Looking northeast at unauthorized pump system on waterside slope.

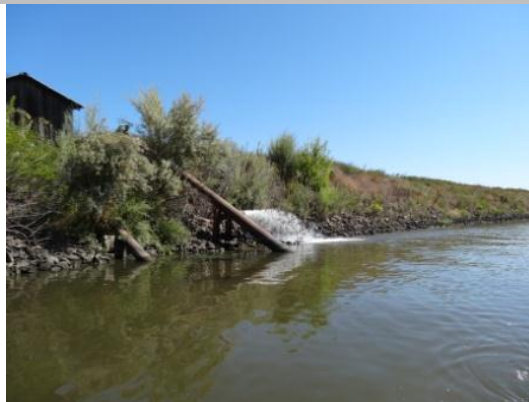
Photo 1 of 1 : richard_s_20140320_321.jpg

LM Start	4.21	Rating **	M	Issue No.	78
LM End	4.22	Issue Type +	Ma	Location *	WS
Category	Supplemental			GPS Latitude/Longitude	
				Start	End
Item	DWR Erosion Survey			37.825248 °	37.825248 °
				-121.313856 °	-121.313856 °
DWR ID	DWR_RD0544_01_s _ 2014_78				
Action/Comments					
Inspector Comments: 08/13/2013: The erosion has been caused by irrigation pipe. [2013 Site ID:RD0544U01RM51.04]

Close view of the site.

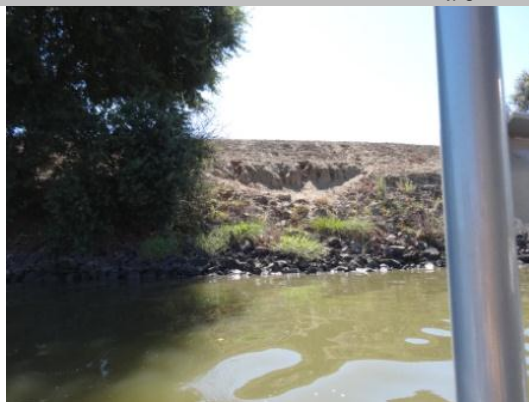
Photo 1 of 1 : richard_s_20140320_322.jpg

LM Start	4.32	Rating **	U	Issue No.	79
LM End	4.32	Issue Type +	Ma	Location *	WS
Category	Supplemental			GPS Latitude/Longitude	
				Start	End
Item	DWR Erosion Survey			37.824360 °	37.824360 °
				-121.314360 °	-121.314360 °
DWR ID	DWR_RD0544_01_s _ 2014_79				
Action/Comments					
Inspector Comments: 08/13/2013: This erosion has been caused by instability of the levee . Larger trees exist downstream of the erosion site. [2013 Site ID:RD0544U01RM51.09]

Looking from upstream at the site.

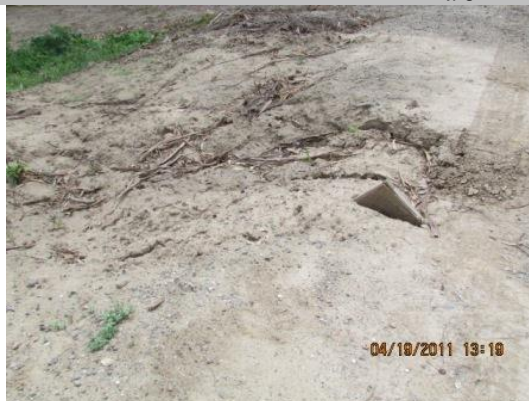
Photo 2 of 2 : richard_s_20140320_308.jpg

Looking southeast at depression on waterside shoulder.

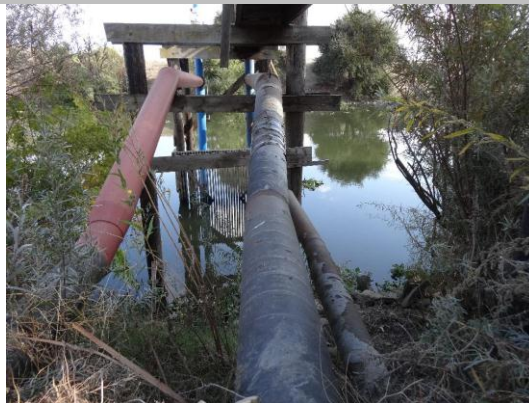
Photo 1 of 1 : UCIP_4347.jpg

LM Start	4.33	Rating **	M	Issue No.	86
LM End	4.33	Issue Type +	En	Location *	CR
Category	Supplemental			GPS Latitude/Longitude	
				Start	End
Item	DWR UCIP Field Study			37.825071 °	37.825071 °
				-121.314932 °	-121.314932 °
DWR ID	DWR_RD0544_01_s _ 2014_86				
Action/Comments					
Inspector Comments: FS_ID:24893

WS view: pipes, pumps, walkway to pump, and pile structure in the stream.

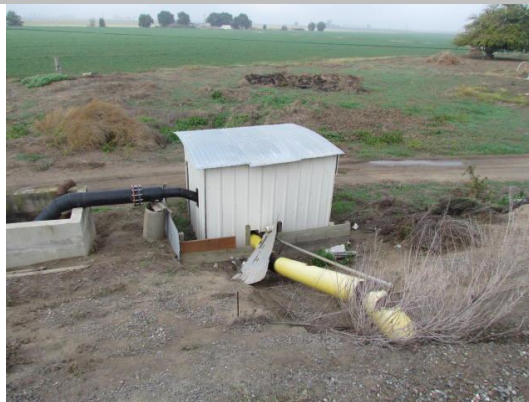
Photo 1 of 1 : richard_s_20140320_305.jpg

LM Start	4.78	Rating **	M	Issue No.	45
LM End	4.78	Issue Type +	En	Location *	LS
Category	Earthen Levee			GPS Latitude/Longitude	
				Start	End
Item	Encroachments				o
					o
DWR ID	DWR_RD0544_01_s _ 2012_45				
Action/Comments					
Building Inspector Comments: New unauthorized pump shed on landside toe.

Looking west at a unauthorized pump house on landside toe.

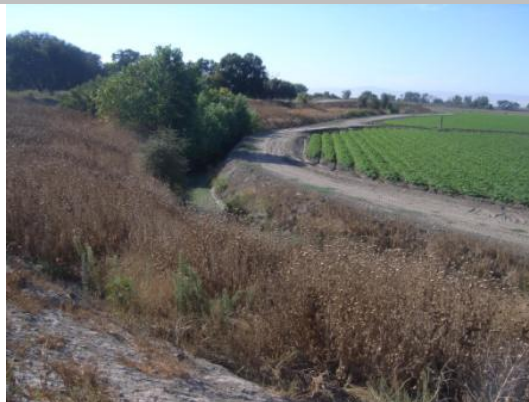
Photo 1 of 1 : richard_s_20140320_323.jpg

LM Start	4.96	Rating **	U	Issue No.	163
LM End	5.05	Issue Type +	En	Location *	LS
Category	Earthen Levee			GPS Latitude/Longitude	
				Start	End
Item	Encroachments			°	37.818125 °
				°	-121.319070 °
DWR ID	DWR_RD0544_01_s _ 2012_163				
Action/Comments					
Ditch Inspector Comments: Agricultural ditch on landside toe.

Looking southwest at ditch on landside slope and toe.

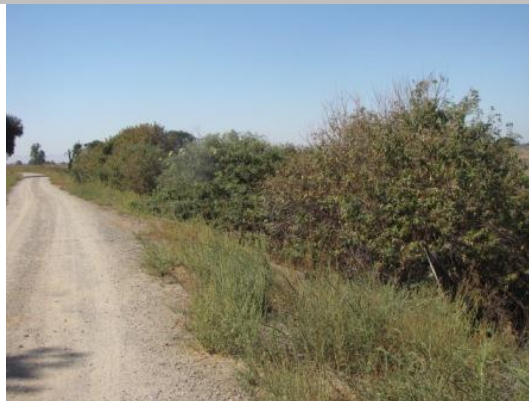
Photo 1 of 2 : richard_s_20140320_297.jpg

Looking southwest on elderberries on landside slope and toe.

LM Start	5.54	Rating **	U	Issue No.	18
LM End	5.60	Issue Type +	Ma	Location *	LS
Category	Earthen Levee			GPS Latitude/Longitude	
				Start	End
Item	Vegetation			37.812033 °	37.811687 °
				-121.319737 °	-121.320677 °
DWR ID	DWR_RD0544_01_s _ 2012_18				
Action/Comments					
Elderberries are blocking visibility and flood fight capability.

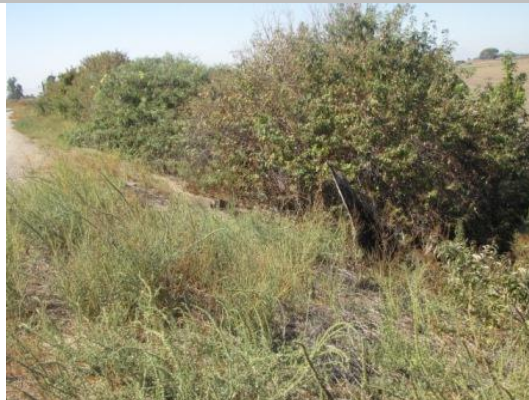
Photo 2 of 2 : richard_s_20140320_298.jpg

Looking south at elderberries on landside slope and toe.

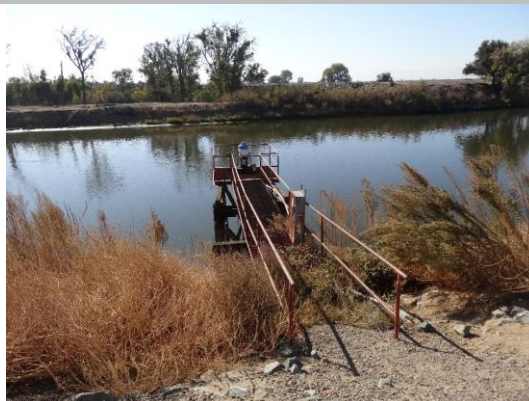
Photo 1 of 1 : UCIP_4074.jpg

LM Start	5.76	Rating **	M	Issue No.	88
LM End	5.76	Issue Type +	En	Location *	LS
Category	Supplemental			GPS Latitude/Longitude	
				Start	End
Item	DWR UCIP Field Study			37.811192 °	37.811192 °
				-121.323531 °	-121.323531 °
DWR ID	DWR_RD0544_01_s_2014_88				
Action/Comments					
Inspector Comments: FS_ID:24233					
EP_NO: N/A					
Repair Type:					
Crossing Status:					
UCIP Comments: - 2-inch electric conduit on watersideservice pole on landsideneeds a cover on pressure relief valve.					
FIELD_STRUCT_DESC: 16-inch steel pipe and electrical conduit through the levee, 5.3 feet below the crown, pump mounted on pile structure in the stream. Steel walkway to the pump. Two 36-inch concrete stand pipes on the landward side. United States Army Corps of Engineers, installation 1962. O&M Manual SJR 007, April 1964.					
FS Date: 10/31/2013

WS view: pump on pile structure, walkway to the pump on levee slope.

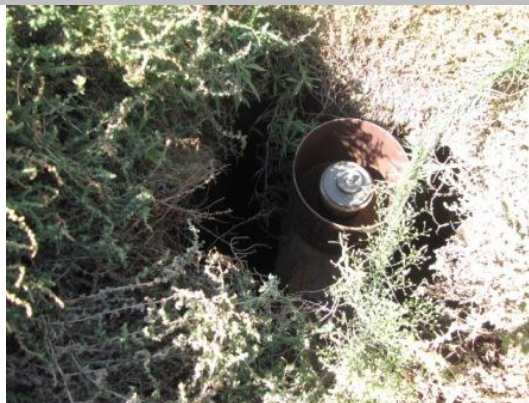
Photo 1 of 8 : richard_s_20140320_339.jpg

LM Start	0.79	Rating **	U	Issue No.	8
LM End	0.79	Issue Type +	Ma	Location *	WS
Category	Interior Drainage & Piping Systems			GPS Latitude/Longitude	
				Start	End
Item	Erosion Areas			37.815102 °	37.815102 °
				-121.333898 °	-121.333898 °
DWR ID	DWR_RD0544_02_s _ 2012_8				
Action/Comments					
Inspector Comments: Caving under and around siphon on waterside shoulder. No material 3' below pipe. Caving around siphon is 20" to 24" deep approximately 72" in diameter. During 2012 spring inspection hole appears to be enlarging.

Looking at top of siphon on waterside shoulder with 3' of caving around pipe.

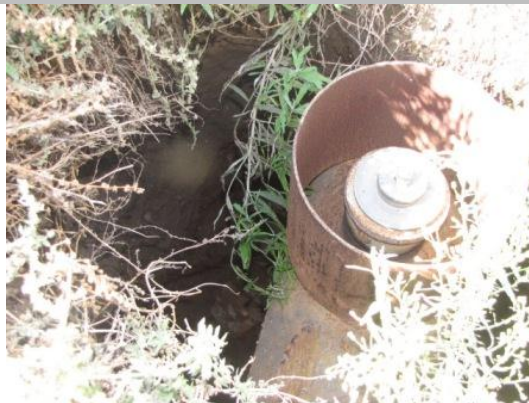
Photo 2 of 8 : richard_s_20140320_340.jpg

Looking at caving around 10" siphon pipe on waterside shoulder.

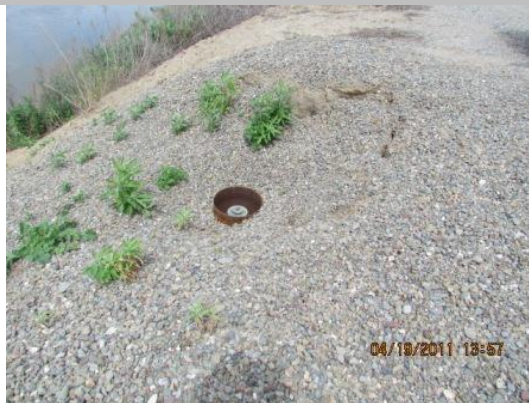
Photo 3 of 8 : richard_s_20140320_341.jpg

Looking south at depression greater than 6" on waterside shoulder.

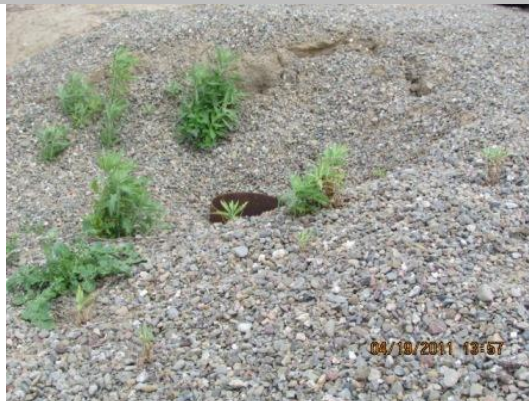
Photo 4 of 8 : richard_s_20140320_342.jpg

Looking south at depression greater than 6" around siphon on waterside shoulder.

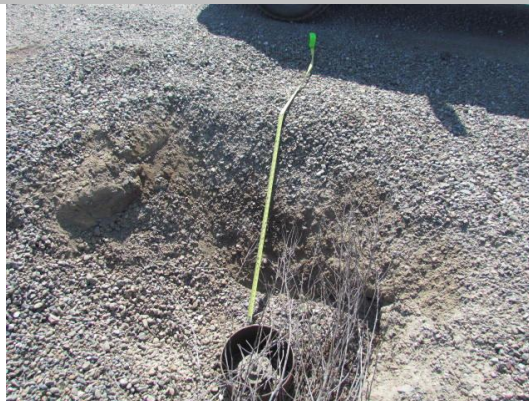
Photo 6 of 8 : richard_s_20140320_344.jpg

Looking west at caving around siphon on waterside shoulder. (Spring 2012)

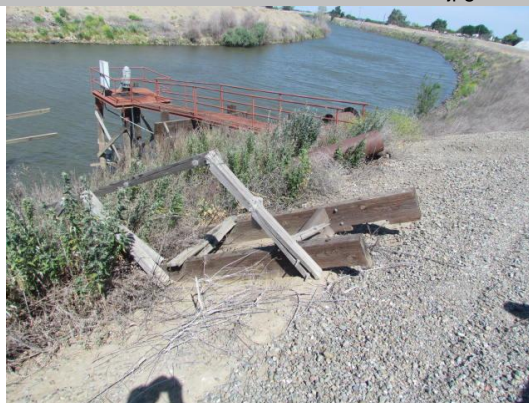
Photo 1 of 1 : richard_s_20140320_338.jpg

Looking southeast at garbage on waterside shoulder and slope.

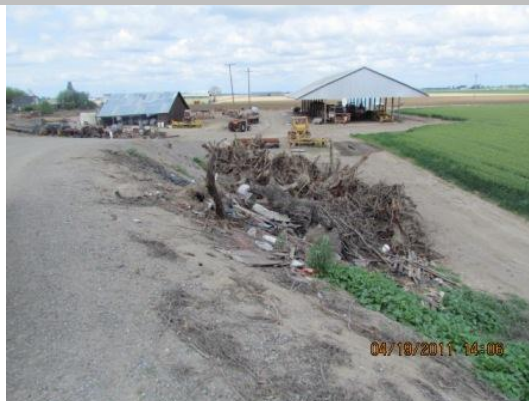
Photo 1 of 3 : richard_s_20140320_357.jpg

LM Start	1.14	Rating **	U	Issue No.	20
LM End	1.14	Issue Type +	En	Location *	LS
Category	Earthen Levee			GPS Latitude/Longitude	
				Start	End
Item	Encroachments			37.819530 °	37.819530 °
				-121.333827 °	-121.333827 °
DWR ID	DWR_RD0544_02_s _ 2012_20				
Action/Comments					
Prunings Inspector Comments: Rubber tires and other items have been added to pruning pile.

Looking southwest at pruning pile on landside slope.

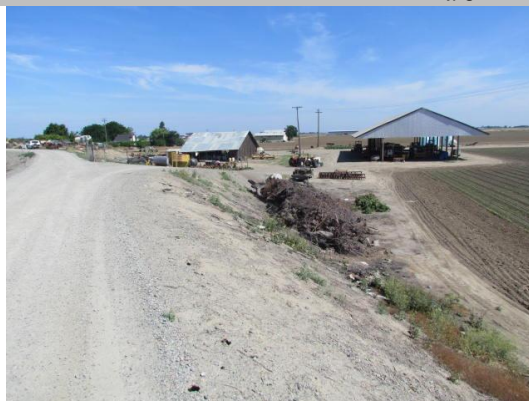
Photo 2 of 3 : richard_s_20140320_358.jpg

Looking southwest at garbage and pruning pile at landside toe.(Spring 2012)

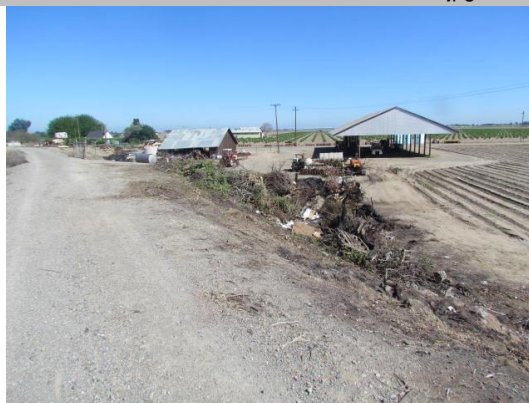
Photo 3 of 3 : richard_s_20140411_534.jpg

Looking southwest at pruning & garbage piles at landward toe. (Spring 2014)

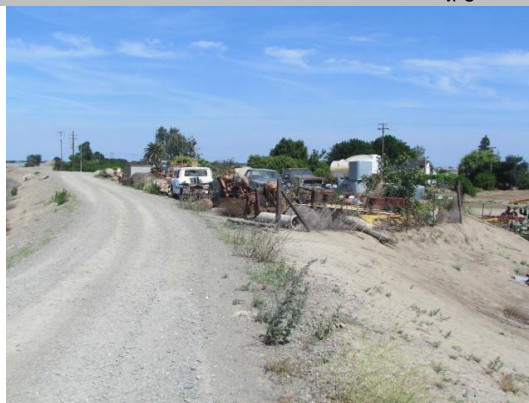
Photo 1 of 3 : richard_s_20140320_354.jpg

LM Start	1.17	Rating **	M	Issue No.	18
LM End	1.23	Issue Type +	En	Location *	LS
Category	Earthen Levee			GPS Latitude/Longitude	
				Start	End
Item	Encroachments			37.819830 °	37.820235 °
				-121.334233 °	-121.335268 °
DWR ID	DWR_RD0544_02_s _ 2012_18				
Action/Comments					
Abandoned vehicles					
Inspector Comments: Vehicles and farm equipment stored on landside for several years. Area is defined a oversize levee.

Looking southwest at vehicles and farm equipment stored on landside landing.

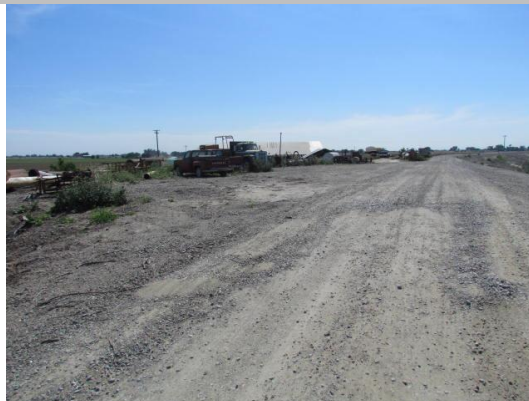
Photo 2 of 3 : richard_s_20140320_355.jpg

LM Start	1.17	Rating **	M	Issue No.	18 (cont)
LM End	1.23	Issue Type +	En	Location *	LS
Category	Earthen Levee			GPS Latitude/Longitude	
				Start	End
Item	Encroachments			37.819830 °	37.820235 °
				-121.334233 °	-121.335268 °
DWR ID	DWR_RD0544_02_s _ 2012_18				
Action/Comments					
Abandoned vehicles					
Inspector Comments: Vehicles and farm equipment stored on landside for several years. Area is defined a oversize levee.

Looking northwest at vehicles and farm equipment stored on landside landing.

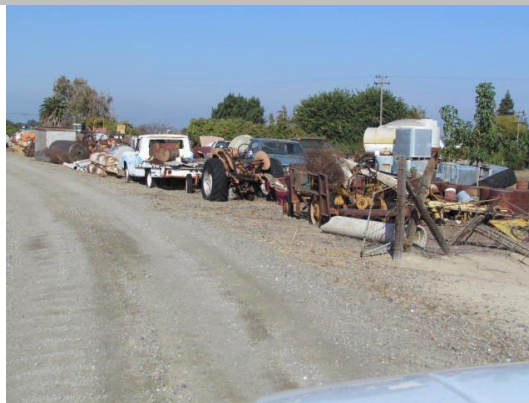
Photo 3 of 3 : richard_s_20140320_356.jpg

Looking southwest at farm equipment, vehicles, and other items stored on landside landing.

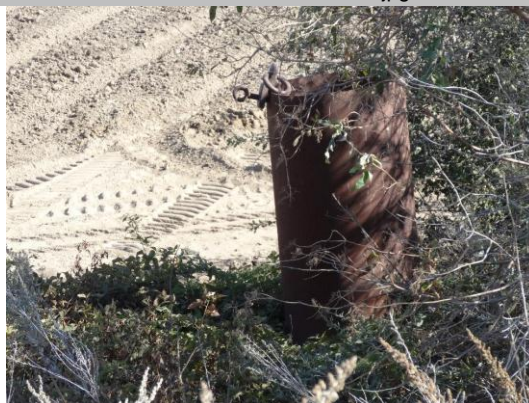
Photo 1 of 1 : UCIP_4362.jpg

LM Start	1.40	Rating **	M	Issue No.	27
LM End	1.40	Issue Type +	En	Location *	WS
Category	Supplemental			GPS Latitude/Longitude	
				Start	End
Item	DWR UCIP Field Study			37.821380 °	37.821380 °
				-121.337835 °	-121.337835 °
DWR ID	DWR_RD0544_02_s_2014_27				
Action/Comments					
Inspector Comments: FS_ID:24905					
EP_NO: N/A					
Repair Type:					
Crossing Status:					
UCIP Comments: - the pipe 3 ft to 4 ft below the crown steel pipe riser on landside but not sure whether it is connected to the pipe. slope erosion on landside.					
FIELD_STRUCT_DESC: 8-inch pipe through the levee, 3.5 ft below the crown; open on both ends. Soil erosion on landside. Steel pipe riser on landside.					
FS Date: 10/31/2013

LS view: steel pipe riser off the levee toe.

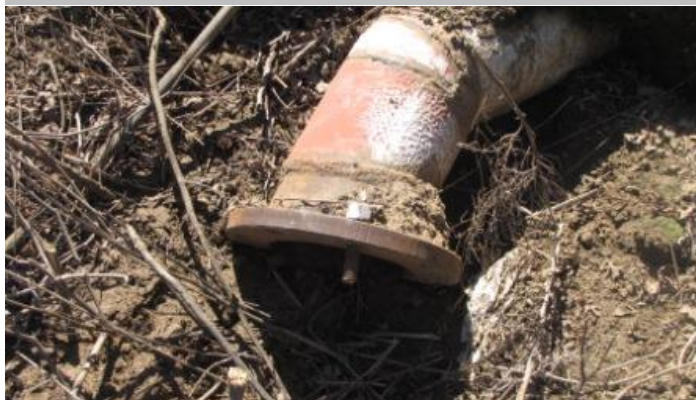
Photo 1 of 3 : richard_s_20140320_360.jpg

LM Start	1.40	Rating **	A/W	Issue No.	21
LM End	1.40	Issue Type +	En	Location *	LS
Category	Earthen Levee			GPS Latitude/Longitude	
				Start	End
Item	Encroachments			37.821463 °	37.821463 °
				-121.337900 °	-121.337900 °
DWR ID	DWR_RD0544_02_s_2012_21				
Action/Comments					
Pipe					
Inspector Comments: Pipe should be removed or properly abandoned.

Looking east at pipe on landside slope.

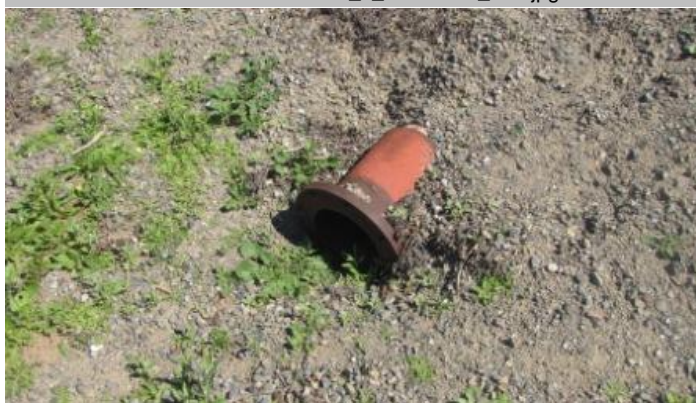
Photo 3 of 3 : richard_s_20140320_362.jpg

Looking west at east end of pipe on waterside slope.

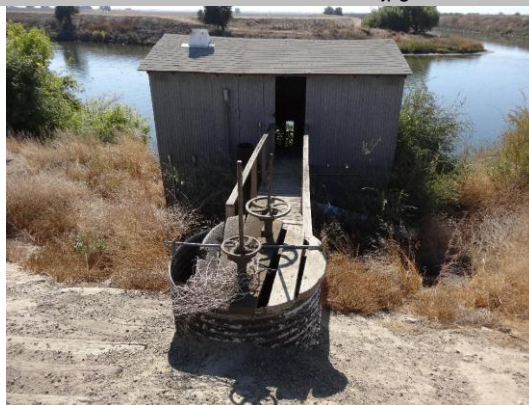
Photo 1 of 1 : UCIP_4082.jpg

LM Start	1.53	Rating **	M	Issue No.	29
LM End	1.53	Issue Type +	En	Location *	LS
Category	Supplemental			GPS Latitude/Longitude	
				Start	End
Item	DWR UCIP Field Study			37.822414 °	37.822414 °
				-121.339698 °	-121.339698 °
DWR ID	DWR_RD0544_02_s _ 2014_29				
Action/Comments					
Inspector Comments: FS_ID:24288					
EP_NO: N/A					
Repair Type:					
Crossing Status:					
UCIP Comments: - two pumps with 16" steel pipe and an abandoned pump with 10" pipe inside pump house.CMP riser cover needs repair- electric conduits on waterside and power pole on landside.					
FIELD_STRUCT_DESC: 24-inch steel pipe through the levee, 14.0 feet below the crown. Pump in pump house on the waterward berm. Slide gate in CM pipe riser on the waterward slope. Two CM cutoff walls. Distribution box and power pole on landward toe. O&M Manual SJR 007, April 1964.					
FS Date: 10/31/2013

WS view: slide gate in CMP riser, walkway, and pumphouse on levee slope.

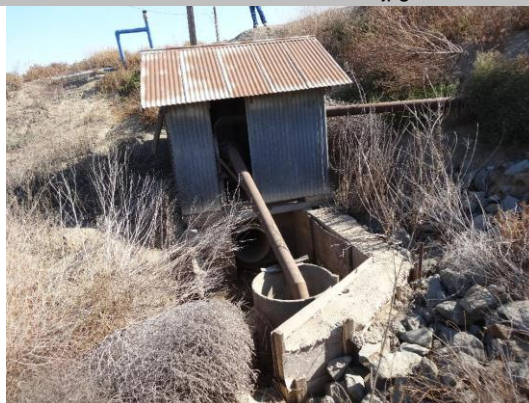
Photo 1 of 1 : UCIP_4367.jpg

LM Start	1.54	Rating **	M	Issue No.	31
LM End	1.54	Issue Type +	En	Location *	LS
Category	Supplemental			GPS Latitude/Longitude	
				Start	End
Item	DWR UCIP Field Study			37.822445 °	37.822445 °
				-121.339910 °	-121.339910 °
DWR ID	DWR_RD0544_02_s_2014_31				
Action/Comments					
Inspector Comments: FS_ID:24907					
EP_NO: N/A					
Repair Type:					
Crossing Status:					
UCIP Comments: No pipe and appurtenances found on waterside looks abandoned.					
FIELD_STRUCT_DESC: An abandoned 8-inch steel pipe through levee. Pump house on landside toe. Air vent in CMP riser on landside shoulder. Outlet on waterside not visible. No positive closure. Appears abandoned.					
FS Date: 10/31/2013

LS view: pipe, pump house, and appurtenances on levee slope.

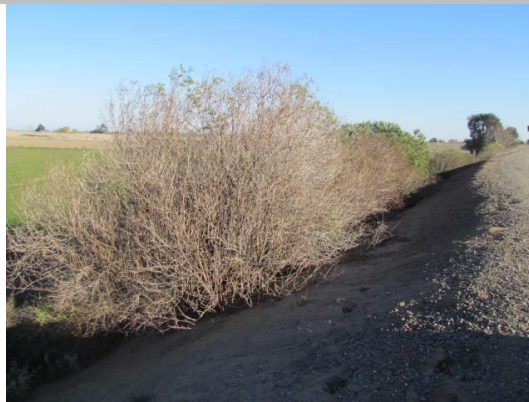
Photo 1 of 1 : richard_s_20140320_351.jpg

LM Start	2.11	Rating **	M	Issue No.	13
LM End	2.12	Issue Type +	Ma	Location *	LS
Category	Earthen Levee			GPS Latitude/Longitude	
				Start	End
Item	Vegetation			37.819337 °	37.819460 °
				-121.344275 °	-121.344492 °
DWR ID	DWR_RD0544_02_s _ 2012_13				
Action/Comments					
Elderberries are blocking visibility and flood fight capability.

Looking northwest at elderberries on landside slope and toe.

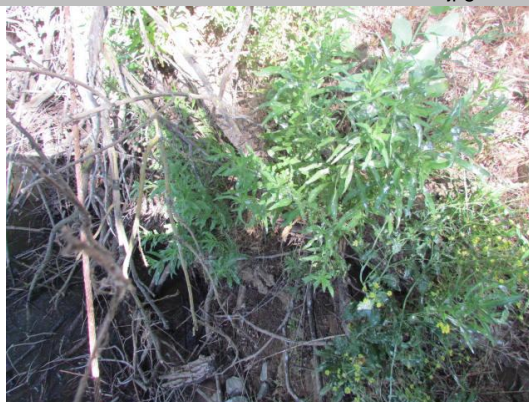
Photo 1 of 3 : richard_s_20140320_365.jpg

LM Start	2.35	Rating **	U	Issue No.	24
LM End	2.35	Issue Type +	Ma	Location *	WS
Category	Channels			GPS Latitude/Longitude	
				Start	End
Item	Erosion / Bank Caving			37.821763 °	37.821763 °
				-121.347275 °	-121.347275 °
DWR ID	DWR_RD0544_02_s _ 2012_24				
Action/Comments					
Inspector Comments: Large erosion and beaver activity at waterside toe of levee.

Looking south at breaver hole at waterside toe.

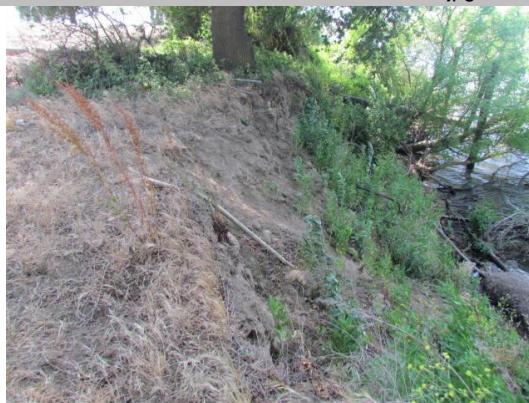
Photo 2 of 3 : richard_s_20140320_366.jpg

LM Start	2.35	Rating **	U	Issue No.	24 (cont)
LM End	2.35	Issue Type +	Ma	Location *	WS
Category	Channels			GPS Latitude/Longitude	
				Start	End
Item	Erosion / Bank Caving			37.821763 °	37.821763 °
				-121.347275 °	-121.347275 °
DWR ID	DWR_RD0544_02_s _ 2012_24				
Action/Comments					
Inspector Comments: Large erosion and beaver activity at waterside toe of levee.

Looking north at erosion on waterside slope.

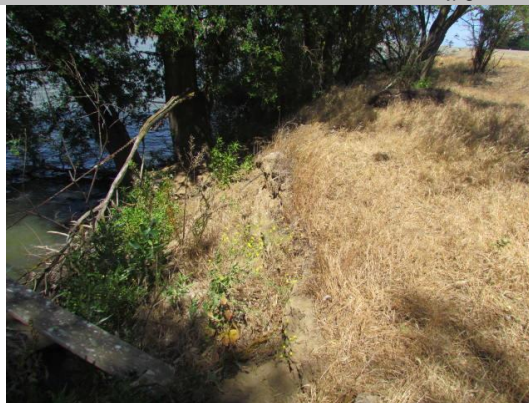
Photo 3 of 3 : richard_s_20140320_367.jpg

Looking south at river erosion at waterside toe near pumping station.

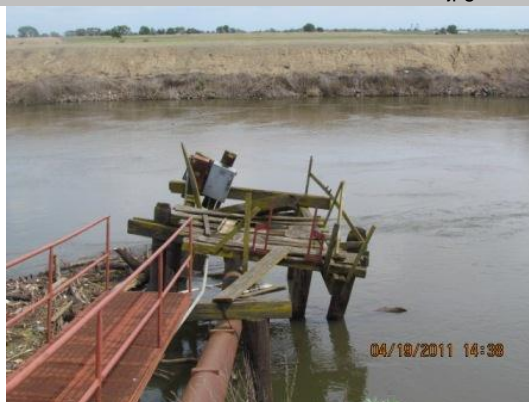
Photo 1 of 1 : richard_s_20140320_353.jpg

LM Start	2.64	Rating **	U	Issue No.	17
LM End	2.64	Issue Type +	En	Location *	WS
Category	Channels			GPS Latitude/Longitude	
				Start	End
Item	Encroachments			37.818872 °	37.818872 °
				-121.350392 °	-121.350392 °
DWR ID	DWR_RD0544_02_s _ 2012_17				
Action/Comments					
Inspector Comments: Remove dilapidated pump platform from river.

Looking east at dilapidated pump platform.

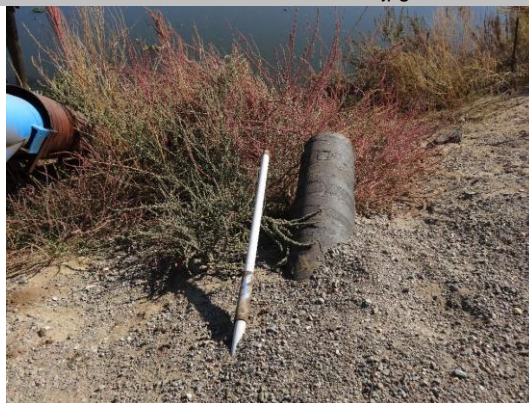
Photo 1 of 1 : UCIP_4092.jpg

LM Start	2.65	Rating **	M	Issue No.	37
LM End	2.65	Issue Type +	En	Location *	WS
Category	Supplemental			GPS Latitude/Longitude	
				Start	End
Item	DWR UCIP Field Study			37.818860 °	37.818860 °
				-121.350428 °	-121.350428 °
DWR ID	DWR_RD0544_02_s_2014_37				
Action/Comments					
Inspector Comments: FS_ID:24297					
EP_NO: N/A					
Repair Type:					
Crossing Status:					
UCIP Comments: - needs proper abandonment or closer of pipe end.					
FIELD_STRUCT_DESC: A 14-inch steel pipe and a conduit through					
levee, 2 feet below the crown. Open on both ends. No other					
appurtenances found.					
FS Date: 10/31/2013

WS view: steel pipe and electric conduit on levee shoulder.

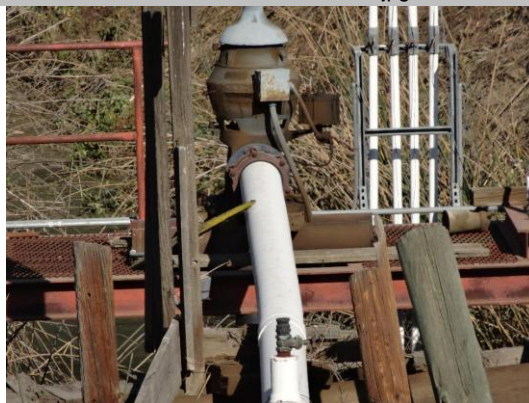
Photo 1 of 1 : UCIP_4368.jpg

LM Start	3.26	Rating **	M	Issue No.	45
LM End	3.26	Issue Type +	En	Location *	LS
Category	Supplemental			GPS Latitude/Longitude	
				Start	End
Item	DWR UCIP Field Study			37.818824 °	37.818824 °
				-121.359526 °	-121.359526 °
DWR ID	DWR_RD0544_02_s_2014_45				
Action/Comments					
Inspector Comments: FS_ID:24908					
EP_NO: 16972					
Repair Type:					
Crossing Status:					
UCIP Comments: Pump not found on the waterward side. Damaged pipe-plug on waterside. Pipe exposed on both sides of the levee.					
FIELD_STRUCT_DESC: 1 of 2: Two 8-inch pvc pipes (replaced two 8-inch steel pipes) through the levee, 2.0 feet below the crown. Siphon breaker on waterside. Pump on steel platform in drainage ditch. (App. No. 16972 - Joseph & Gayle Muller)					
FS Date: 10/31/2013

LS view: pump on steel platform over drainage ditch.

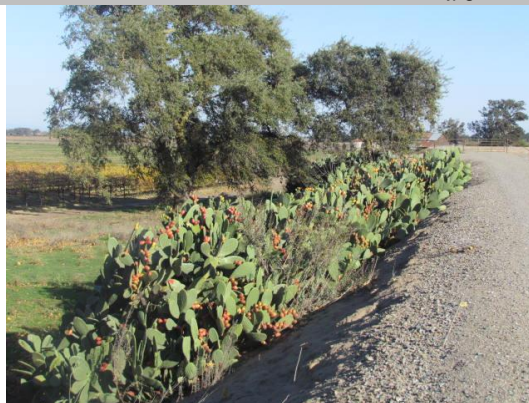
Photo 2 of 2 : richard_s_20140320_369.jpg

LM Start	3.53	Rating **	M	Issue No.	36 (cont)
LM End	3.56	Issue Type +	Ma	Location *	LS

Looking north at cactus on landside slope and toe.

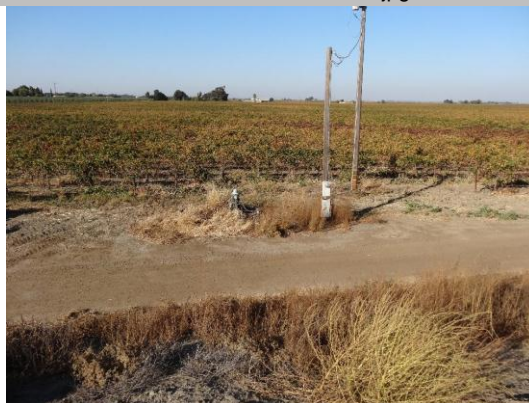
Photo 1 of 1 : UCIP_4097.jpg

LM Start	4.03	Rating **	M	Issue No.	46
LM End	4.03	Issue Type +	En	Location *	WS
Category	Supplemental			GPS Latitude/Longitude	
				Start	End
Item	DWR UCIP Field Study			37.821700 °	37.821700 °
				-121.371751 °	-121.371751 °
DWR ID	DWR_RD0544_02_s_2014_46				
Action/Comments					
Inspector Comments: FS_ID:24304					
EP_NO: 16357					
Repair Type:					
Crossing Status:					
UCIP Comments: - pipe 3 ft below the crown. Pit and holes on the pipe and the levee. no vent pipe found on waterside. No concrete vent pipe found at the landside toe. was working during the field inspection.					
FIELD_STRUCT_DESC: 10-inch steel pipe through the levee, 3.0 feet below the crown. Open on waterside end. O&M Manual SJR 7, April 1964.					
FS Date: 11/19/2013

LS view: pump on concrete sump and service pole off the levee toe.
